# Updated information on the possible presence of a crack on one of the steel chain links of the Petzl ZIGZAG and ZILLON

July 23, 2014

This message follows the information issued May 19, 2014

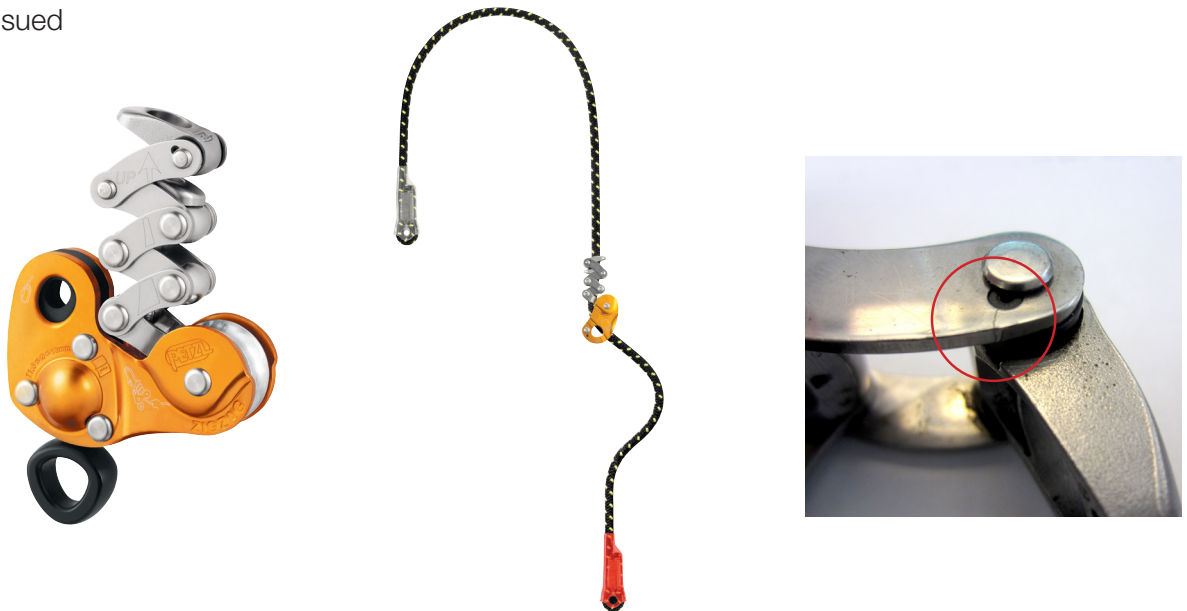
- Several ZIGZAGs have been returned to Petzl with a cracked friction chain link.
- The return rate remains below 2/1000.
- No incidents or accidents have been reported to us.
- Both ZIGZAG and ZILLON friction chain links are affected.
- When a crack appears, it is always on the same side of the friction chain links.
- All devices returned to us with a cracked link have been replaced under warranty.

Petzl has identified the root causes of the appearance of these cracks. They are the result of a combination of three parameters:

- Riveting parameters on one side that create potential residual tensile stress in the friction chain link.
- The small cross section of the link near the rivet position.
- Heat treatment that results in this part being too rigid.

- A crack can appear over time. The gradual appearance of these cracks makes them undetectable during final inspection.
- Only a very low percentage of ZIGZAG/ZILLON devices (2 out of 1000) may potentially develop such a crack.

- Adjustment of the riveting parameters for the link assembly to eliminate residual tensile stress in the link.
- Reinforcement of the small cross section of the affected links.
- Adjustment of the heat treatment parameters of the link to reduce rigidity of the material.

- A cracked link presents no additional immediate risk to the user. However, as with any personal protective equipment (PPE), the presence of such a crack requires immediate retirement of the device.
- Considering the very low rates of potentially cracked links, and taking into consideration that a cracked link presents no additional immediate risk to the user, only cracked devices will be replaced.
- The replacement of a cracked device will be carried out under warranty. The warranty for this defect has been extended to 10 years.
- Regularly inspect your device in accordance with the Petzl PPE checking procedure.
- In the unlikely event you find a cracked link, retire your device immediately and contact the Petzl distributor in your country.
