## Safety Alert

Stop use Petzl ZIGZAG mechanical Prusik

Sku. D22

This information is complementary to the Safety Information issued April 15, 2013

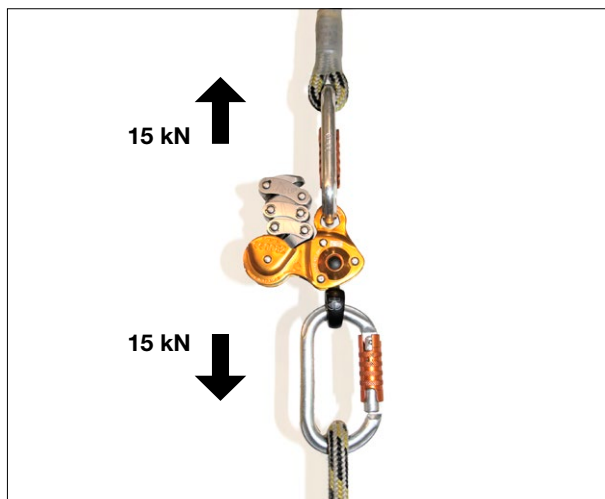
#### 1/3 - Breaking strength of the ZIGZAG's rope end attachment hole

With this carabiner configuration, the breaking strength of the rope end attachment hole is greater than 15 kN.

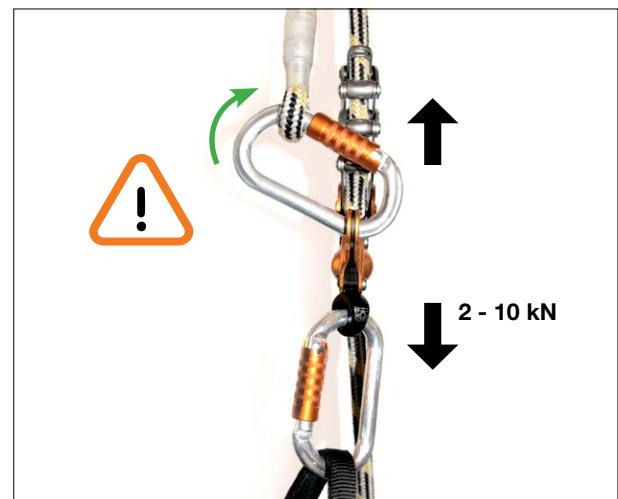
#### 2/3 - ZIGZAG with a cantilevered upper carabiner

This is an incorrect configuration.

*Note: most of the carabiners tested this way pivot and correct themselves to be loaded on the major axis starting at 2 kN of force. Some carabiners pivoted and corrected themselves at 10 kN, without damaging the upper attachment hole.*

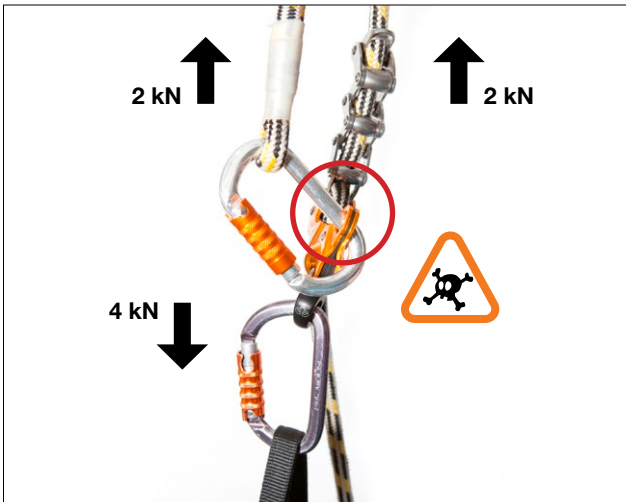
### 3/3 - ZIGZAG with a cantilevered and off axis upper loaded upper carabiner

This is an incorrect configuration.

**In this configuration, we have observed a failure of the rope end attachment hole of the ZIGZAG under 4 kN of charge (equivalent to short fall, repeated shock or sudden stop, etc).**

The cantilevered upper carabiner in this particular configuration multiplies the forces applied to the rope end attachment hole, leading to its failure.

**1 - As a measure of precaution, we ask that you stop using your ZIGZAG mechanical Prusik.**
