Information for the users of the Petzl ZIGZAG

May 19, 2014

April 08, 2014

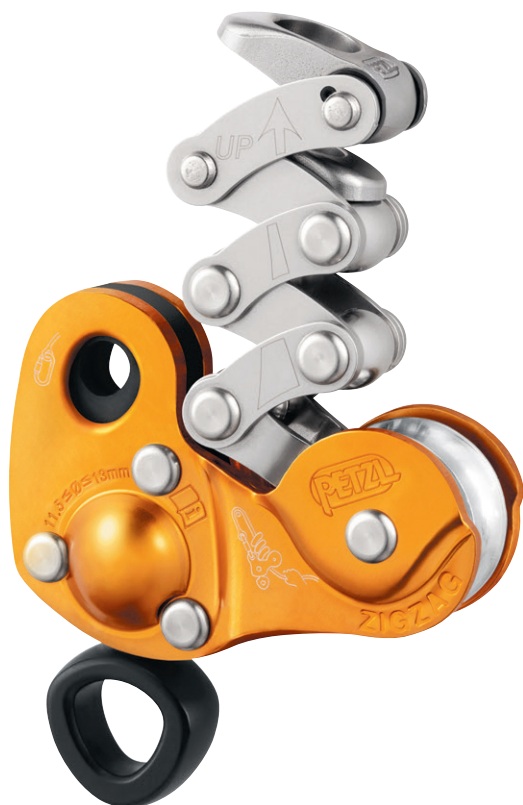
- As of today, six cracked ZIGZAGs have been returned to us. There have been no incidents or accidents; all of these ZIGZAGs have been replaced under warranty.
- The search for potential causes is still in progress: we sent cracked ZIGZAGs to an independent laboratory for in-depth metallurgical analysis. The analysis did not allow us to identify the cause of the cracks. In addition, we are working with our steel chain link supplier to find a potential explanation.

- Regularly inspect your ZIGZAG in accordance with the ZIGZAG PPE checking procedure.
- In the unlikely event you find a cracked link, retire your ZIGZAG immediately and contact your Petzl distributor for a replacement under warranty.
- A cracked link presents no immediate additional risk to the user. However, as with all PPE, the presence of such a crack requires immediate retirement of the ZIGZAG.
- These recommendations therefore also apply to the Petzl ZILLON.

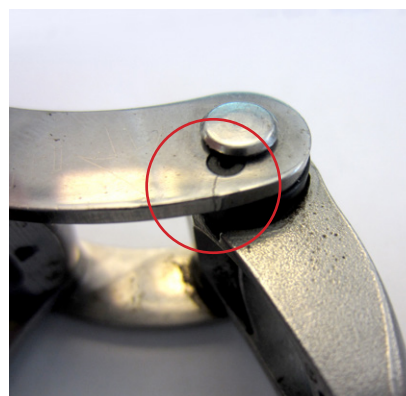
Two different customers have informed us of the presence of a crack on one of the ZIGZAG's steel chain links. Both units have been returned to Petzl for analysis.

- Regularly inspect your ZIGZAG in accordance with the ZIGZAG PPE checking procedure.
- In the unlikely event you find a cracked link, retire your ZIGZAG immediately and contact your local Petzl distributor for a replacement under warranty.
- A cracked link presents no additional immediate risk to the user. However, like for any PPE, the presence of such a crack requires immediate retirement of the ZIGZAG.
- These recommendations therefore apply also to the Petzl ZILLON.

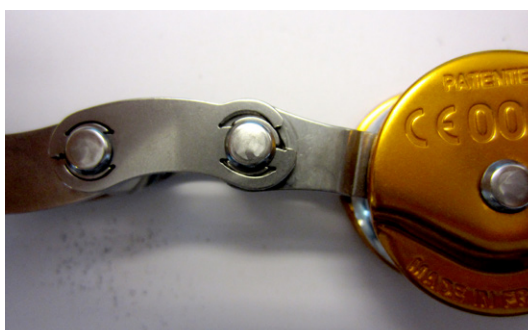
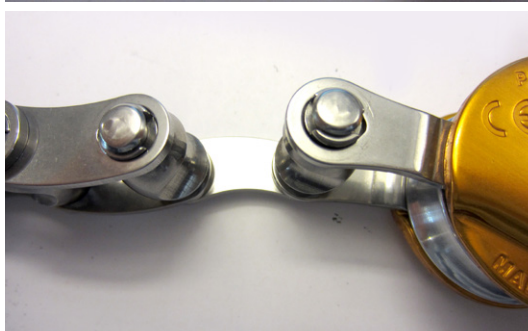
- In a dynamic suspension, the cut link is deformed but not broken (see photos below).

A cracked link presents no additional risk to the user. However, the presence of such a crack requires immediate retirement of the ZIGZAG.
