Updated information on the possible presence of a crack on one of the steel chain links of the Petzl ZIGZAG and ZILLON

November 3, 2014: this message follows the July 23, 2014 communiqué

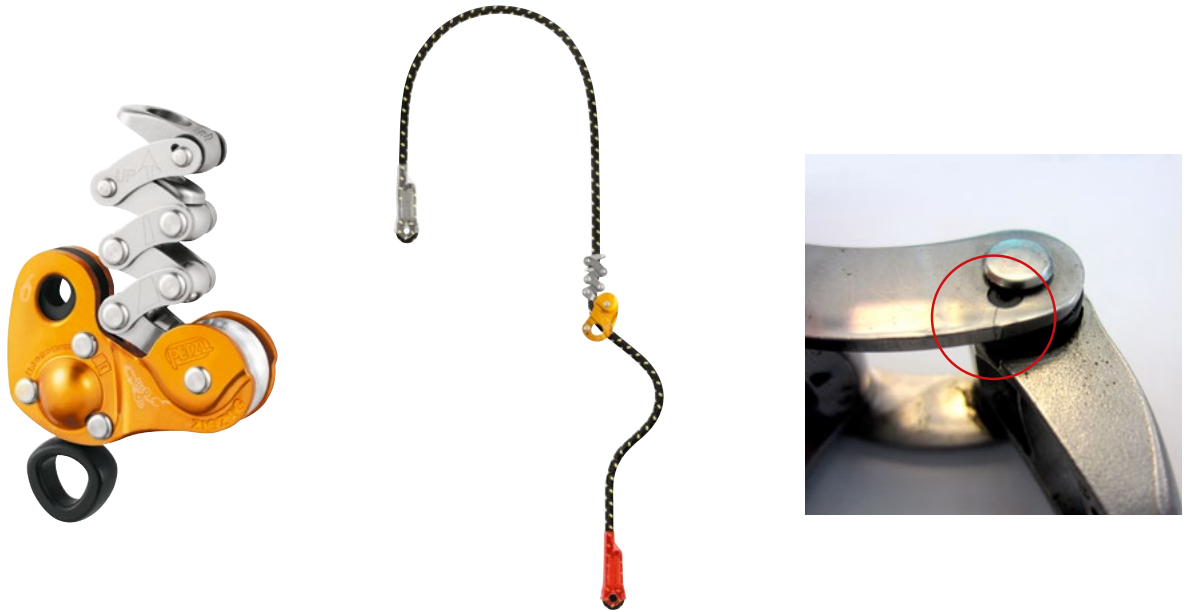
- Several ZIGZAGs with cracked friction chain links have been returned to Petzl.
- The worldwide return rate remains below 4/1000, but may be higher in some countries.
- **No incidents or accidents have been reported to us.**
- Both ZIGZAG and ZILLON friction chain links are affected.
- When a crack appears, it is always on the same side of the friction chain links.
- All devices returned to us with a cracked link have been replaced under warranty.

Petzl has identified the root causes for the appearance of these cracks. These cracks are the result of a combination of three parameters:

- Riveting parameters on one side that create a potential residual tensile stress in the friction chain link.
- The small cross section of the link near the rivet position.
- Heat treatment that results in the cross section being too rigid.

- A cracked link presents no additional immediate risk to the user. However, as with any personal protective equipment (PPE), the presence of such a crack requires immediate retirement of the device.
- Considering the very low rates of potentially cracked links, and taking into consideration that a cracked link presents no additional immediate risk to the user, only cracked devices will be replaced.
- The replacement of a cracked device will be done under warranty. The warranty for this defect has been extended to 10 years.
- Regularly inspect your device in accordance with the Petzl PPE checking procedure.
- In the unlikely event you find a cracked link, retire your device immediately and contact the Petzl distributor in your country.

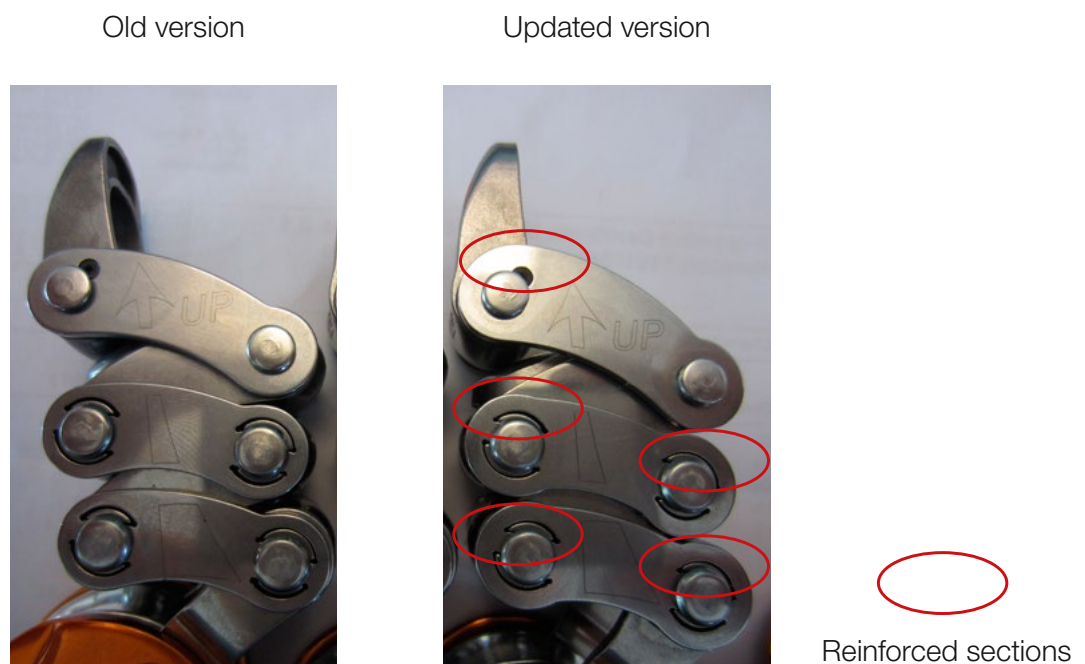
- Adjustment of the riveting parameters for the link assembly to eliminate residual tensile stress in the link.
- Adjustment of heat treatment parameters for the link to reduce rigidity of the material.
- Reinforcement of the small cross section of the affected links.
