## Safety Alert

Stop use Petzl ZIGZAG mechanical Prusik

Sku. D22

This information is complementary to the Safety Information issued April 15, 2013

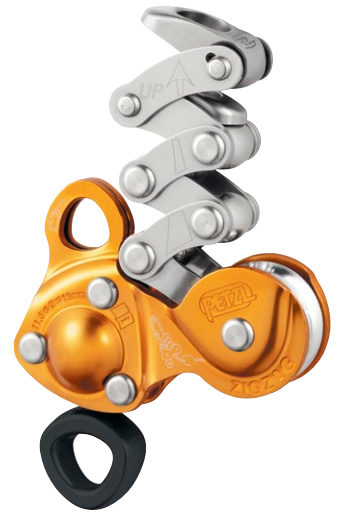
On Friday, April 12, Petzl was informed of an accidental fall in a training center in Germany. The injured person was moving at height using a Petzl ZIGZAG mechanical Prusik. The initial observations have shown that the fall was due to a failure of the rope end attachment hole. Our investigation and further testing lead us to conclude that this failure was the result of a particular configuration of a cantilevered and off axis loaded upper carabiner.

**1 - As a measure of precaution, we ask that you stop using your ZIGZAG mechanical Prusik.**

2 - This stoppage will remain in place until we have approved and communicated an appropriate solution to maximize the safety of ZIGZAG users.

3 - We have decided to stop sales of ZIGZAG mechanical Prusiks.
